**Flood Control Project Maintenance  
Levee Inspections**

## Maintenance Issue Types Only, Levee Inspection Report By Mile - Spring 2019

### Reclamation District No. 2101 Blewett

Waterway	Bank	Unit Miles	Inspection Start/End	Inspector
Unit No. 01 San Joaquin River	Left	3.16	05/22/2019 05/22/2019	Alberto De Leon

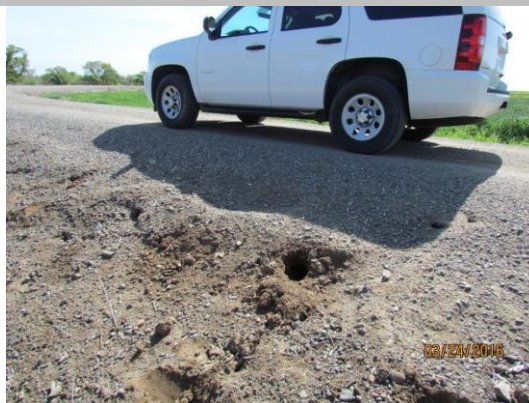
Photo 1 of 1 : SP\_2019\_RD2101\_326\_12\_20190313\_00005.jpg

LM Start	0.04	Rating **	M	Issue No.	12
LM End	0.04	Issue Type +	Ma	Location *	WS
Category	Earthen Levee			GPS Latitude/Longitude	
				Start	End
Item	Animal Control			37.657648 °	37.657648 °
				-121.253812 °	-121.253812 °
DWR ID	DWR_RD2101_01_s_2012_12				
Comment Code					
A3 : No rodents visible, but rodent burrows visible; need to backfill and compact or grout burrows.					
Inspector Comment					
LMA is actively exterminating rodents in this area.

View of the rodent holes on the waterside levee slope, facing upstream.

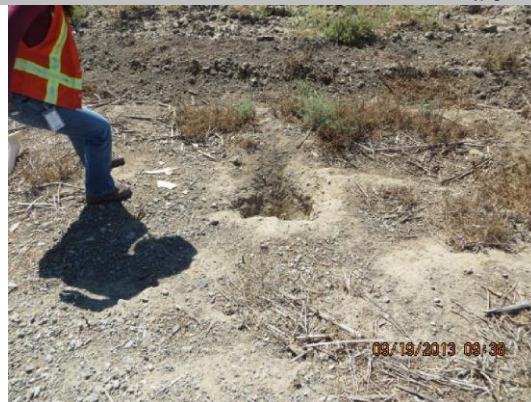
Photo 1 of 3 : UCIP\_SP\_2019\_53384\_47962.jpg

Comment Code					
Inspector Comment					
FS_ID:53384 DS_ID:20699 EP_NO: N/A Repair Type: Non-Urgent Crossing Status: Found UCIP Comments: 10/10/2018 The levee does not show any signs of integrity issues and the headwalls are in tact, even though the pipe has heavy sediment buildup. Downgrading to Non-Urgent and recommend cleaning out the pipe to allow drainage to pass through unobstructed (D. Sanoski - DWR UCIP). 11/16/2016 Same as previous inspection slide gate still missing. Also dense vegetation prevents access to crossing. Recommend removing vegetation along pipe alignment and both concrete headwalls to conduct proper inspection of structure. (O. Magana - DWR UCIP)09/17/2013 Slide gate missing from WS toe. Pipe has heavy sediment buildup. (W. Wylie - DWR UCIP) FIELD_STRUCT_DESC: 18-inch corrugated metal drainage pipe through the levee, 3 feet below the crown. Concrete headwalls on both ends. Slide gate at the headwall on the waterside (WS) end. [Additional Reference(s): DWR Levee Log, 1992. USACE San Joaquin O&M Manual 12, December 1968, (HLM 0.05), Drawing No. 07-04-1666, Sheets 1666/18 and 1666/52, (Station 00+70)]. FS Date: 10/10/2018 1:39:00 PM

Headwall on WS toe.

Pipe and headwall visible on LS toe.

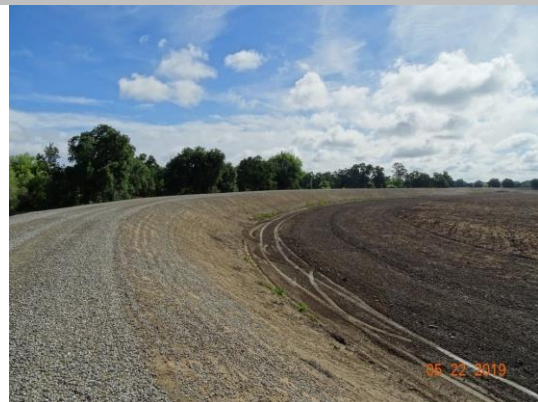
Photo 1 of 1 : SP\_2019\_RD2101\_326\_39\_20190522\_00054.jpg

LM Start	0.08	Rating **	A	Issue No.	39
LM End	2.74	Issue Type +	Ma	Location *	LS
Category	Earthen Levee			GPS Latitude/Longitude	
				Start	End
Item	Vegetation			37.657823 °	37.641545 °
				-121.253292 °	-121.229744 °
DWR ID	DWR_RD2101_01_s_2019_39				
Comment Code					
V1 : Control annual grass and weeds on the levee slopes and easements.					
Inspector Comment					
Annual vegetation on landside slope is well maintained.

Typical view of vegetation on landside slope. (Spring 2019)

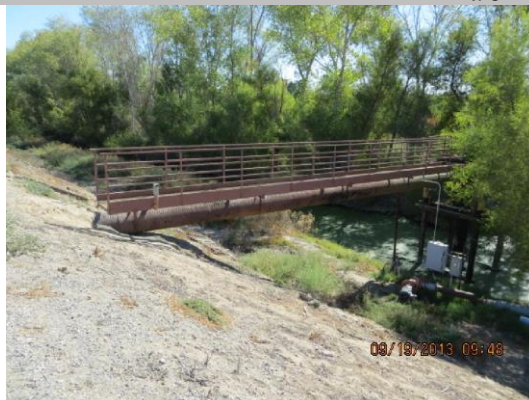
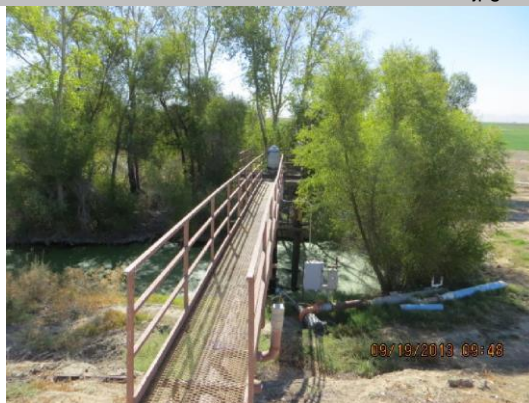
Photo 1 of 3 : UCIP\_SP\_2019\_20752\_34980.jpg

LM Start	0.20	Rating **	A/W	Issue No.	946
LM End	0.20	Issue Type +	Ma	Location *	
Category	Supplemental			GPS Latitude/Longitude	
				Start	End
Item	DWR UCIP LMA Responsibility			37.657130 °	37.657130 °
				-121.251695 °	-121.251695 °
DWR ID	20700				
Comment Code					
Inspector Comment					
FS_ID:20752					
DS_ID:20700					
EP_NO: N/A					
Repair Type: No Action Needed					
Crossing Status: Found					
UCIP Comments:					
FIELD_STRUCT_DESC: 20-inch steel drainage pipe through the levee, 2 feet below the crown. Concrete U-shaped headwall and flap gate on the waterside (WS) end. Pump on pile structure on the landside (LS). [Additional Reference(s): DWR Levee Log, 1992. USACE San Joaquin O&M Manual 12, December 1968, (HLM 0.20), 18-inch pipe listed].					
FS Date: 9/19/2013

Pump on platform at LS.

Concrete U-shaped headwall on LS toe at willow tree on WS toe.

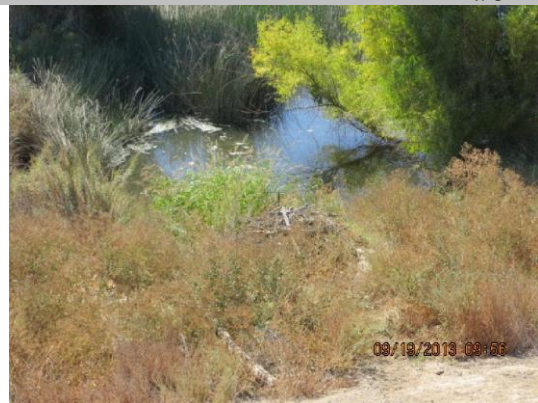
Photo 1 of 3 : UCIP\_SP\_2019\_20785\_35046.jpg

LM Start	0.31	Rating **	M	Issue No.	947
LM End	0.31	Issue Type +	Ma	Location *	
Category	Supplemental			GPS Latitude/Longitude	
				Start	End
Item	DWR UCIP LMA Responsibility			37.658142 °	37.658142 °
				-121.250047 °	-121.250047 °
DWR ID	20701				
Comment Code					
Inspector Comment					
FS_ID:20785 DS_ID:20701 EP_NO: N/A Repair Type: Non-Urgent Crossing Status: Found UCIP Comments: Inlet blocked by soil from beaver activity. Outlet covered in soil. FIELD_STRUCT_DESC: 24-inch corrugated metal drainage pipe through the levee, 21 feet below the crown. Headwall and slide gate on the landside (LS) end. Concrete U-shaped headwall and flap gate on the waterside (WS) end. [Additional Reference(s): DWR Levee Log, 1992. USACE San Joaquin O&M Manual 12, December 1968, (HLM 0.31)]. FS Date: 9/19/2013

Slide gate at concrete headwall on LS toe.

Outlet covered in soil but likely at willow tree on WS slope.

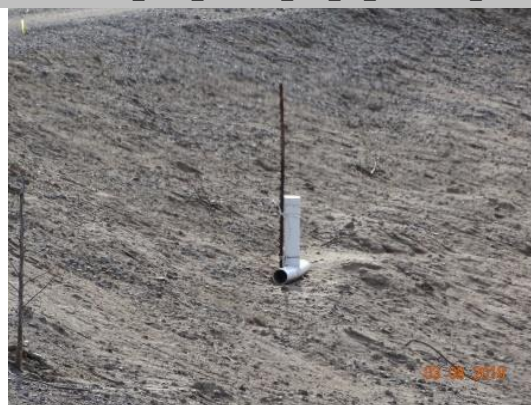
Photo 1 of 1 : SP\_2019\_RD2101\_326\_19\_20190313\_00010.jpg

View of the bait station on the levee slope.

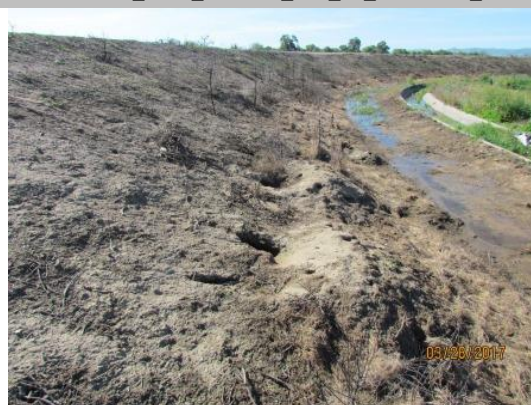
Photo 1 of 1 : SP\_2019\_RD2101\_326\_25\_20190313\_00014.jpg

View of the multiple rodent burrows on the levee slope.

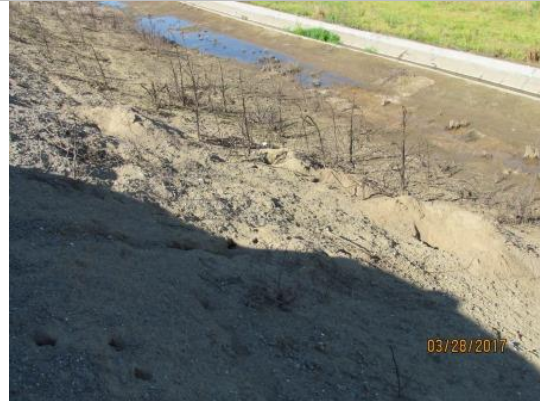
Photo 1 of 1 : SP\_2019\_RD2101\_326\_36\_20190313\_00020.jpg

View of the multiple rodent burrows on the levee slope.

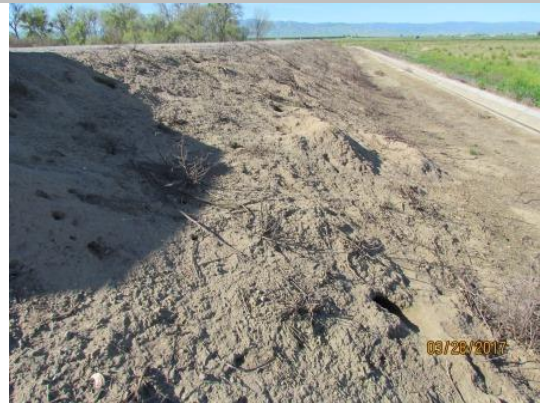
Photo 1 of 1 : SP\_2019\_RD2101\_326\_37\_20190313\_00021.jpg

LM Start	2.67	Rating **	U	Issue No.	37
LM End	2.67	Issue Type +	Ma	Location *	LS
Category	Earthen Levee			GPS Latitude/Longitude	
				Start	End
Item	Animal Control			37.642436 °	37.642436 °
				-121.229854 °	-121.229854 °
DWR ID	DWR_RD2101_01_s_2017_37				
Comment Code					
A3 : No rodents visible, but rodent burrows visible; need to backfill and compact or grout burrows.					
Inspector Comment

View of the multiple rodent burrows on the levee slope.

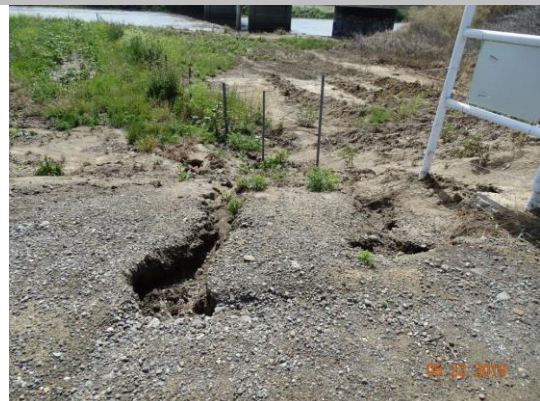
Photo 1 of 1 : SP\_2019\_RD2101\_326\_49\_20190522\_00056.jpg

LM Start	2.74	Rating **	U	Issue No.	49
LM End	2.74	Issue Type +	Ma	Location *	WS
Category	Earthen Levee			GPS Latitude/Longitude	
				Start	End
Item	Erosion / Bank Caving			37.641545 °	37.641545 °
				-121.229744 °	-121.229744 °
DWR ID	DWR_RD2101_01_s_2019_49				
Comment Code					
E2 : Schedule repair of erosion site prior to the next inspection.					
Inspector Comment					
There is erosion on the waterside shoulder extending down the slope. Most likely caused by surface runoff from adjacent highway. Scheduled for repair.

Waterside shoulder erosion most likely caused by surface runoff from adjacent highway. RD has scheduled repair. (Spring 2019)

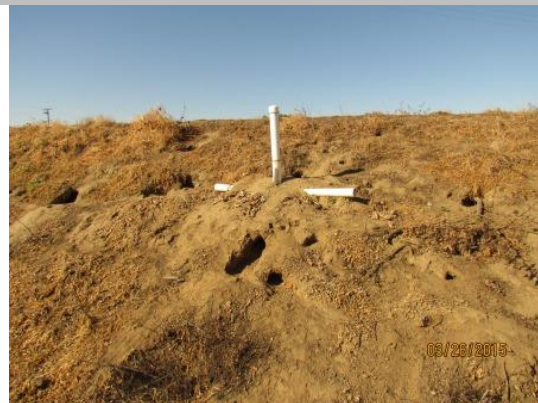
Photo 1 of 1 : SP\_2019\_RD2101\_326\_27\_20190313\_00016.jpg

LM Start	2.83	Rating **	U	Issue No.	27
LM End	2.83	Issue Type +	Ma	Location *	WS
Category	Earthen Levee			GPS Latitude/Longitude	
				Start	End
Item	Animal Control			37.640425 °	37.640425 °
				-121.230139 °	-121.230139 °
DWR ID	DWR_RD2101_01_s_2012_27				
Comment Code					
A3 : No rodents visible, but rodent burrows visible; need to backfill and compact or grout burrows.					
Inspector Comment					
There are burrows on both sides of the levee. Backfill the burrows to restore the levee to original condition.

View of multiple rodent holes on the levee slope.

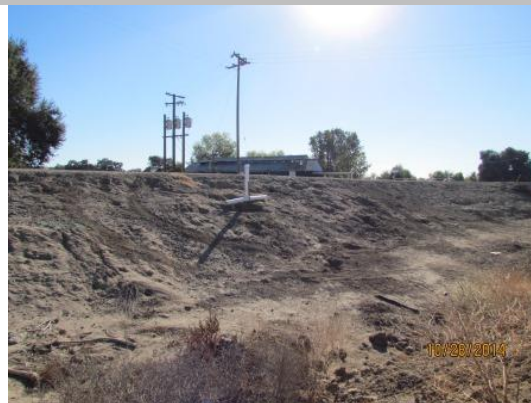
Photo 1 of 1 : SP\_2019\_RD2101\_326\_28\_20190313\_00017.jpg

View of numerous rodent holes with bait stations present.

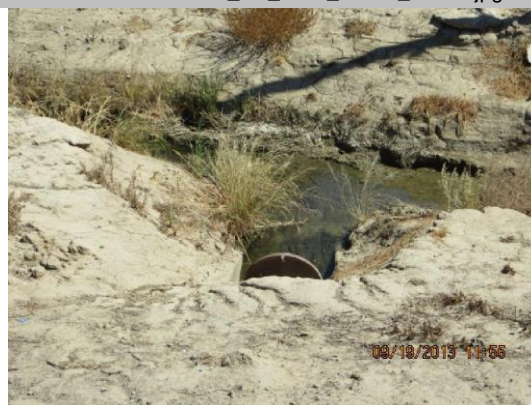
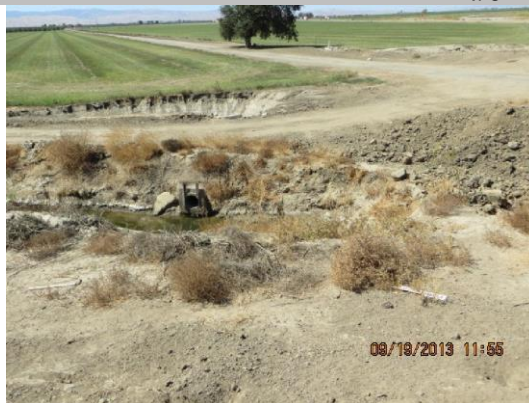
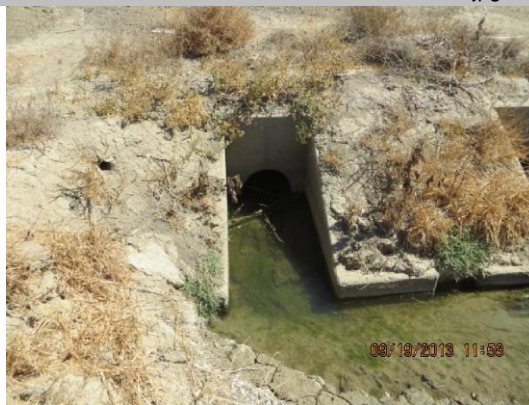
Photo 1 of 3 : UCIP\_SP\_2019\_20875\_35156.jpg

LM Start	2.87	Rating **	A/W	Issue No.	953
LM End	2.87	Issue Type +	Ma	Location *	
Category	Supplemental			GPS Latitude/Longitude	
				Start	End
Item	DWR UCIP LMA Responsibility			37.639924 °	37.639924 °
				-121.230005 °	-121.230005 °
DWR ID	20707				
Comment Code					
Inspector Comment					
FS_ID:20875					
DS_ID:20707					
EP_NO: N/A					
Repair Type: No Action Needed					
Crossing Status: Found					
UCIP Comments:					
FIELD_STRUCT_DESC: 1 of 2: 24-inch corrugated metal drainage pipe through the levee, 12.5 feet below the crown. Concrete U-shaped headwalls on each end. Flap gate on the waterside (WS) end.					
[Additional Reference(s): DWR Levee Log, 1992. USACE San Joaquin O&M Manual 12, December 1968, (HLM 2.89)].					
FS Date: 9/19/2013

Flapgate on WS toe at concrete headwall.

Inlet on LS toe with concrete headwall.

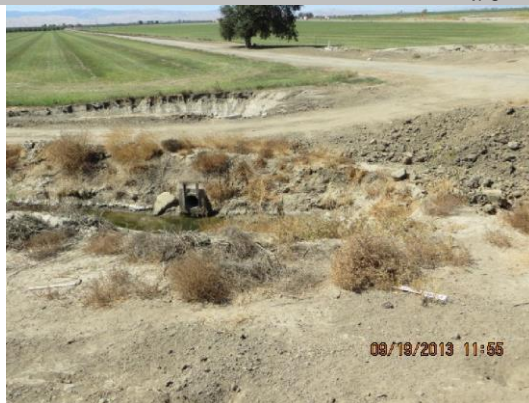
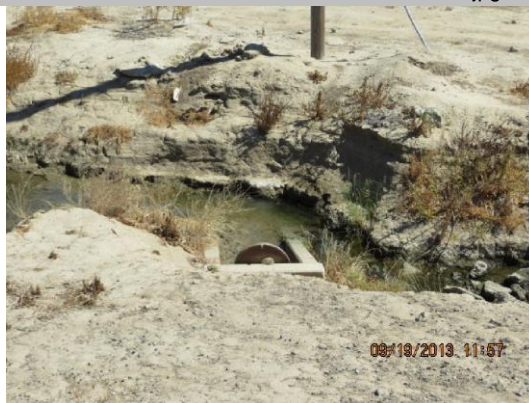
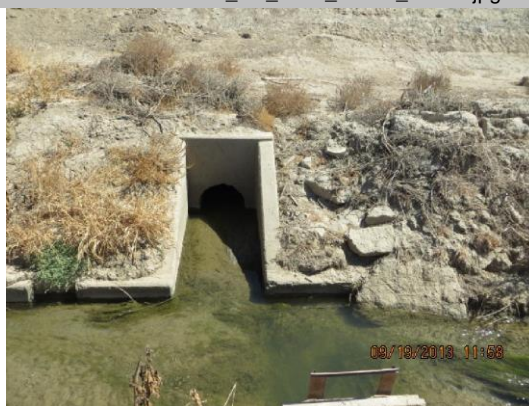
Photo 1 of 3 : UCIP\_SP\_2019\_20876\_35159.jpg

LM Start	2.87	Rating **	A/W	Issue No.	954
LM End	2.87	Issue Type +	Ma	Location *	
Category	Supplemental			GPS Latitude/Longitude	
				Start	End
Item	DWR UCIP LMA Responsibility			37.639884 °	37.639884 °
				-121.230008 °	-121.230008 °
DWR ID	20709				
Comment Code					
Inspector Comment					
FS_ID:20876					
DS_ID:20709					
EP_NO: N/A					
Repair Type: No Action Needed					
Crossing Status: Found					
UCIP Comments:					
FIELD_STRUCT_DESC: 2 of 2: 24-inch drainage pipe of an unknown material through the levee, 12.5 feet below the crown. Concrete U-shaped headwalls on each end. Flap gate on the waterside (WS) end. [Additional Reference(s): DWR Levee Log, 1992. USACE San Joaquin O&M Manual 12, December 1968, (HLM 2.89)].					
FS Date: 9/19/2013

Concrete inlet on LS toe at canal.

Concrete U-shaped headwall on WS toe with flapgate.

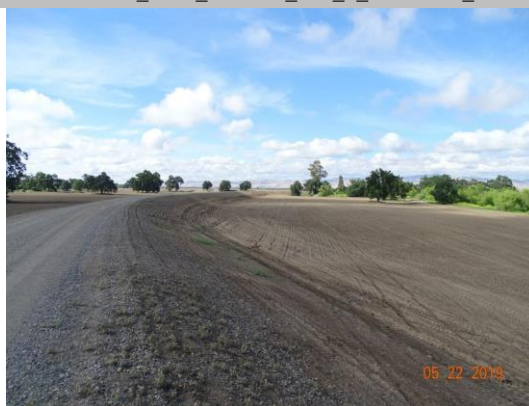
Photo 1 of 1 : SP\_2019\_RD2101\_327\_3\_20190522\_00002.jpg

Typical view of vegetation on landside slope. (Spring 2019)
